## Roof Management Report

Synergy V  
656 Bizzell Dr  
656 Bizzell Dr, Lexington, KY

Prepared For  
Synergy V

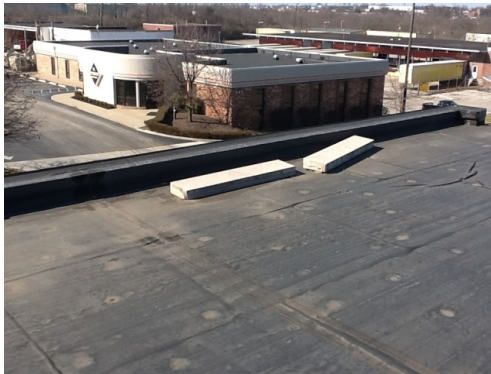
**General - Loose Debris (Remedial)**

Quantity: 4 EA

Loose debris has a high probability of blowing around on the roof and causing damage to the waterproofing membrane.

Remove loose debris from roof area

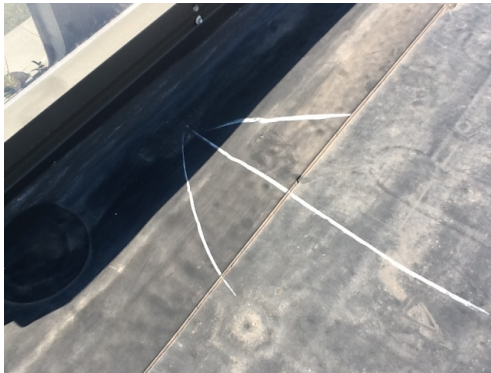
**General - Membrane Fish Mouth (Emergency)**

Quantity: 1 EA

Example of fish mouths on membrane laps that is allowing water into the system.

We will cut the fish mouth out, clean and prime the area and install new patch over effected area to ensure water tightness.

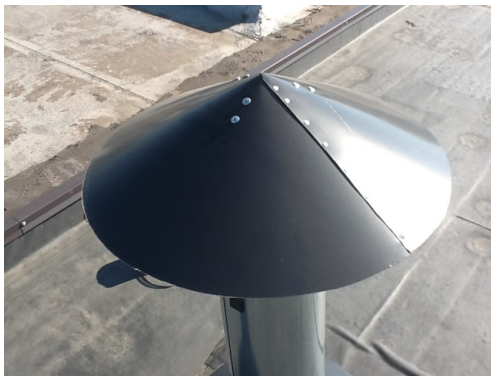
**General - Other (Emergency)**

Quantity: 1 EA

Open seams and exposed fasteners in vent cap

Seal open seam &amp; exposed fasteners.

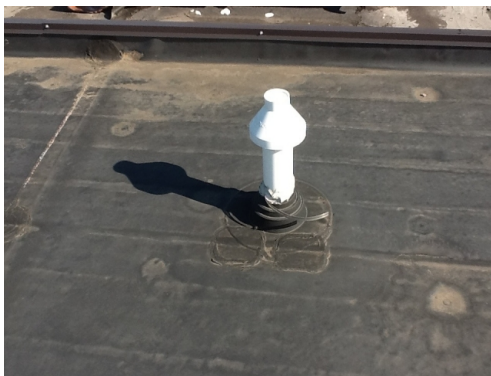
**General - Failing Penetration (Remedial)**

Quantity: 2 EA

Due to overall age, weathering and UV the penetration has failed.

The penetration should be repaired/flushed per industry standards to ensure a water tight seal.

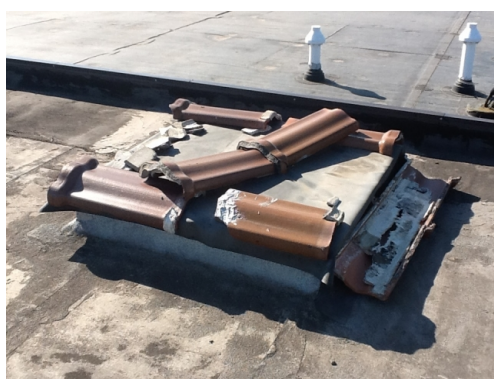
**General - Damaged Skylight (Emergency)**

Quantity: 1 EA

Skylight dome is damaged and needs to be replaced.

We will replace the dome as needed

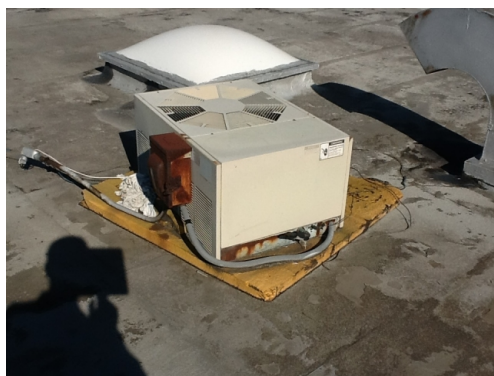
**General - Loose Debris (Remedial)**

Quantity: 1 EA

Loose debris has a high probability of blowing around on the roof and causing damage to the waterproofing membrane.

Remove loose debris from roof area

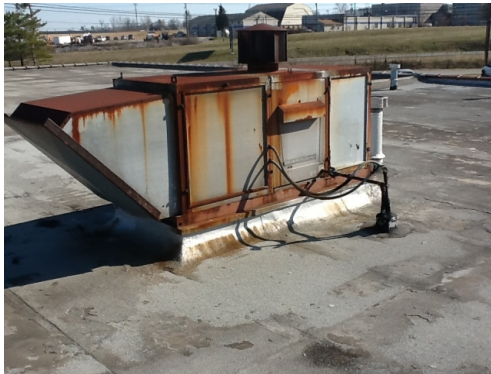
**General - Other (Remedial)**

Quantity: 1 EA

Abandoned HVAC

Disconnect and remove decommissioned HVAC unit. Cap curve to ensure no water intrusion.

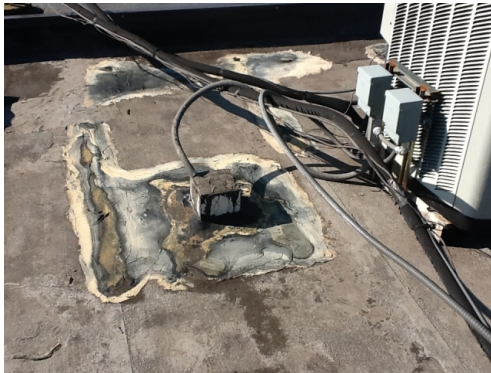
**General - Failing Penetration (Emergency)**

Quantity: 2 EA

Due to overall age, weathering and UV the penetration has failed.

The penetration should be repaired/flushed per industry standards to ensure a water tight seal.

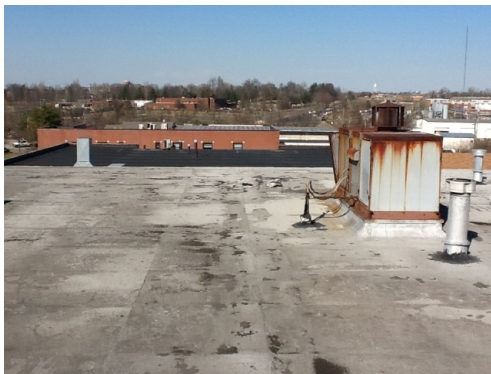
**General - Blisters (Emergency)**

Quantity: 10 EA

Blisters in the membrane are due to either air or moisture being caught between the plies of the waterproofing system. As expansion and contraction occur, what was once a small deficiency enlarges greatly, cracks and allows water into the roof system and building.

The blister must be X cut, filled with a waterproofing agent and re-sealed per industry standards.

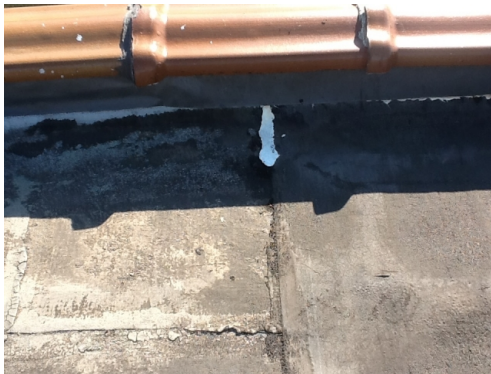
**General - Splits (Emergency)**

Quantity: 10 LF

Splits in the membrane are typically due to building movement and lateral stress. As the membrane ages and weathers, it cannot withstand these forces and split open allowing water to enter the roof system.

The area surrounding the split must be cleaned. A new piece of waterproofing membrane would be installed and sealed per industry standards.

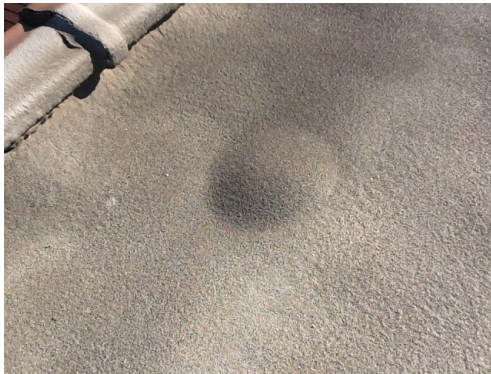
**General - Blisters (Emergency)**

Quantity: 2 EA

Blisters in the membrane are due to either air or moisture being caught between the plies of the waterproofing system. As expansion and contraction occur, what was once a small deficiency enlarges greatly, cracks and allows water into the roof system and building.

The blister must be X cut, filled with a waterproofing agent and re-sealed per industry standards.

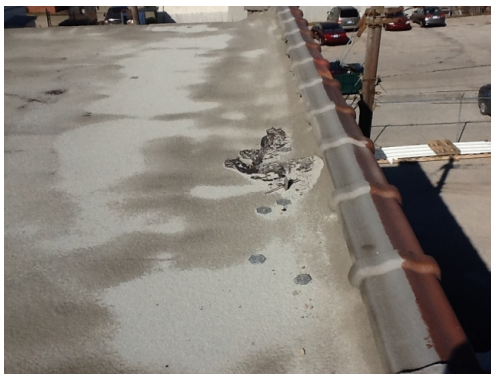
**General - Loose Debris (Remedial)**

Quantity: 1 EA

Loose debris has a high probability of blowing around on the roof and causing damage to the waterproofing membrane.

Remove loose debris from roof area
